River Clean Up Report

The Electron Hydro River Clean Up Report consists of a summary of the project, purpose for river clean up, and daily log of river clean-up work for the 2020 Electron Hydro Diversion Repair, Spillway Replacement and Bank Protection Project (Intake Project).

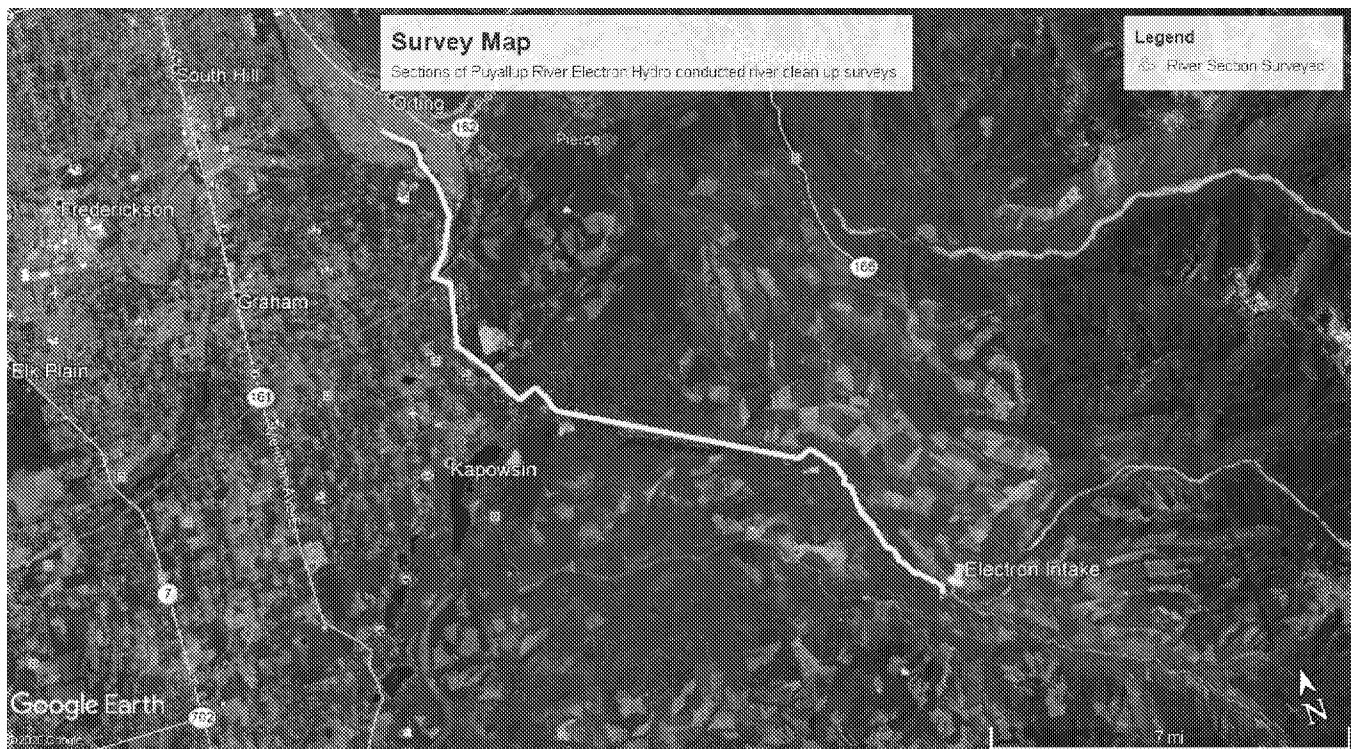
Image 1 shows the total section of river that Electron, to date, has surveyed. Image 2 shows both the points given to Electron from the tribe (grey arrows) as well as new locations where Electron found debris. It should be noted that no black crumb was found from the intake to the powerhouse, the only debris that was found in this section was Field turf and plastic liner, all material at this point was saved and stored in a storage Conex (see image 9). From intake to powerhouse 100% of debris that was found was recovered from this section. Given the constant fluidity changes from the river it is hard to know if all material has been recovered yet. More debris was found on the second and third surveys through same section of river. Approximately 75% of what was found in this section was found within the first 2 miles downstream from the intake where the river braids out and deposits more materials and bedload. The remaining 25% was found between 2-3 miles downstream from the intake.

Image 1: Electron Hydro Survey Map – Section of Puyallup River surveyed. (Covering approx. 19 miles)

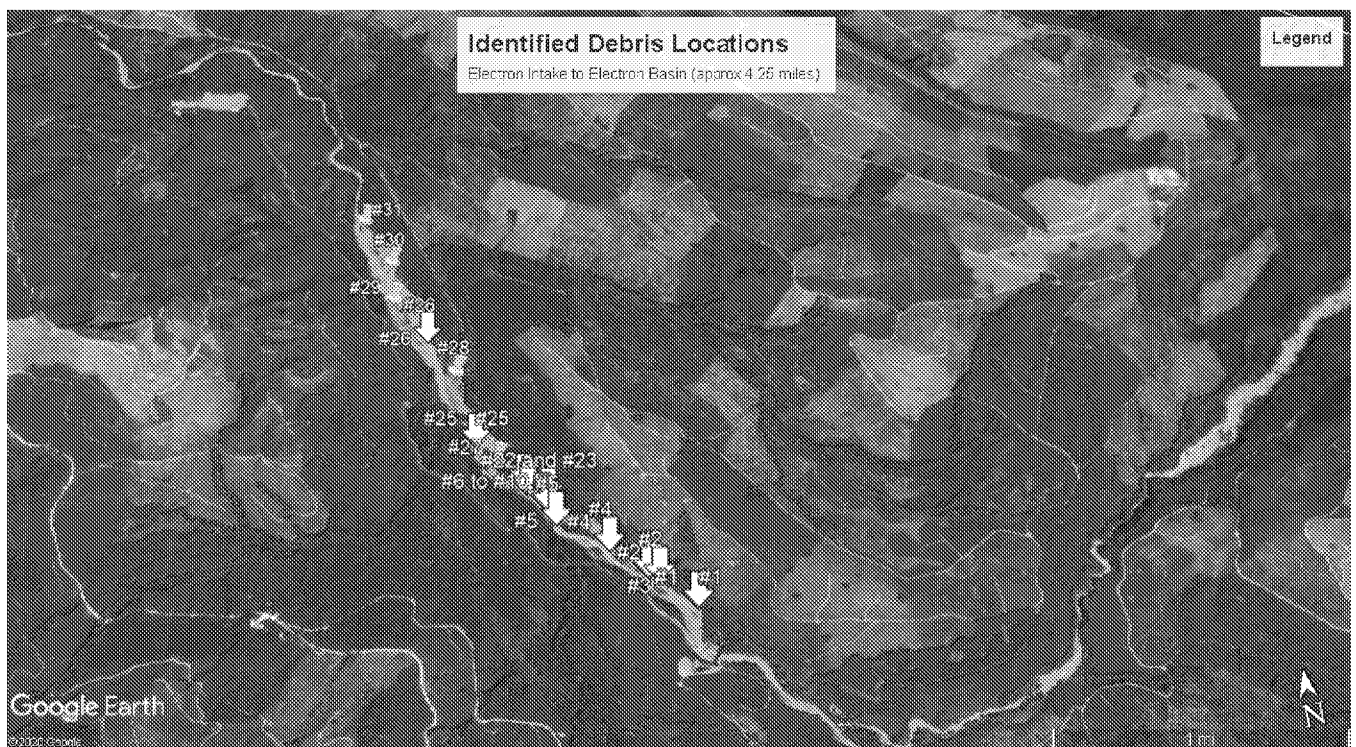
Image 2: Electron Intake to Basin. Marked points of where debris was identified and removed. Debris found - pieces of Field Turf and Plastic Liner (approx. 4.25 miles)

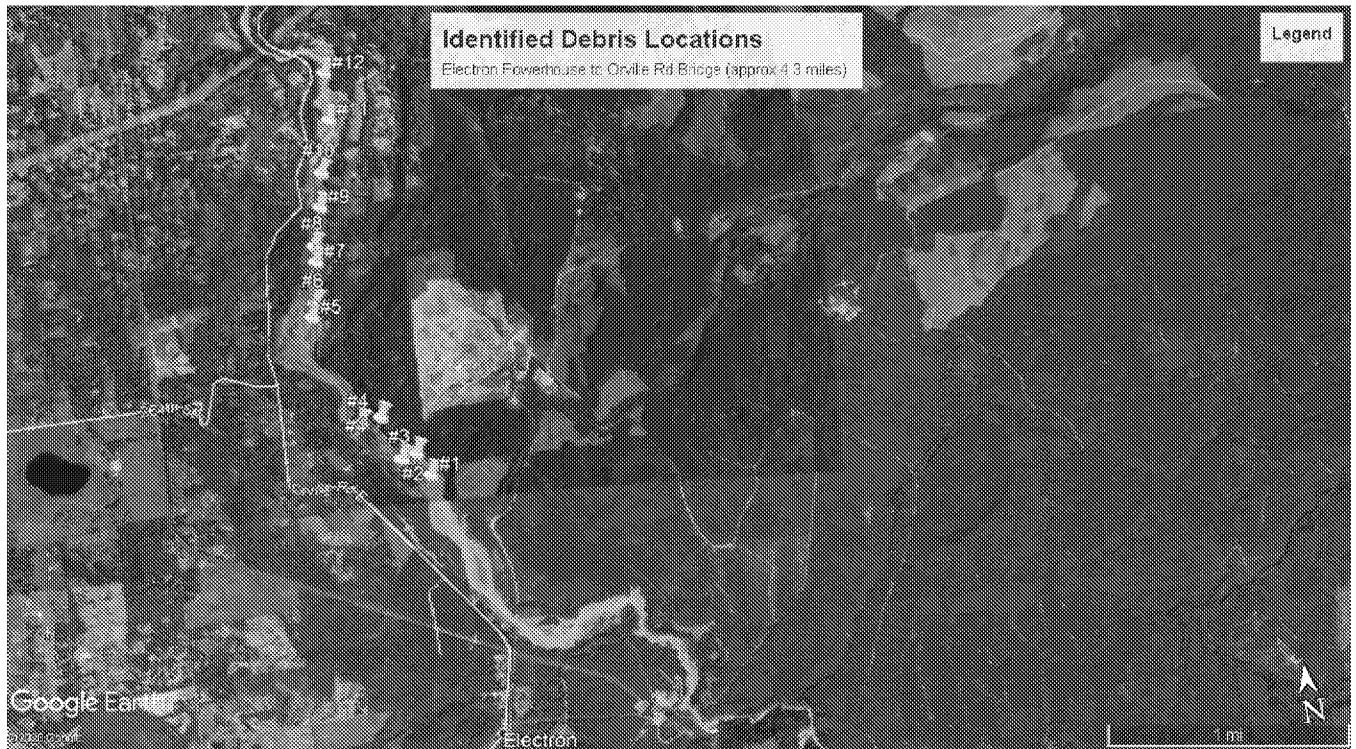
Image 3 shows points identified from Electron surveying from the powerhouse to Calistoga bridge. It should be noted that the only debris found in this section of the river was the black crumb, no larger pieces of debris (e.g. turf or plastic liner) was found in this section. The black crumb that was found was between 1.75

and 2.5 miles downstream from the powerhouse. The total amount of black crumb found was approx. 1/5 of a 5-gallon bucket, 1 full sandwich sized Ziplock bag, and two grocery bags.

Image 3: Electron Powerhouse to Orville Rd Bridge. Marked points of where debris was identified and removed. Debris found - black crumb from Field Turf (approx. 4.3 miles)

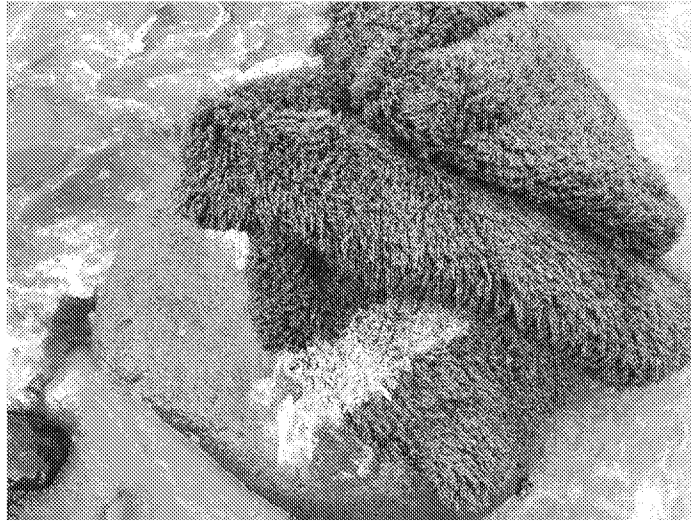
Image 4. Turf piled in river for collection. Photo taken Sep 12, 2020

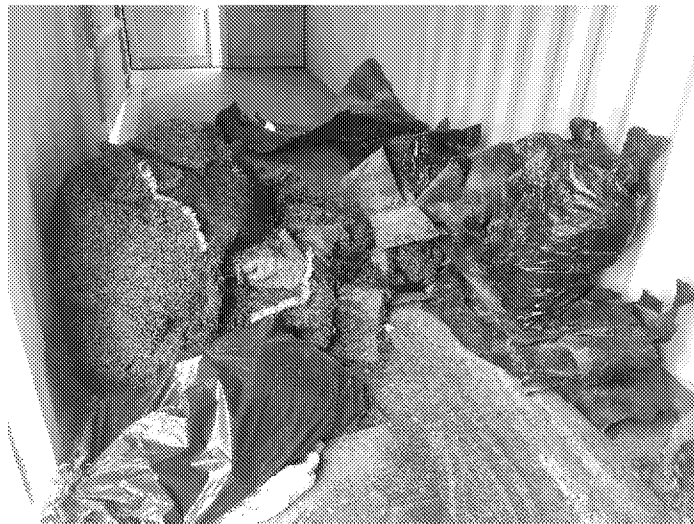
Image 5. Turf and plastic liner stored in storage container. Photo taken Sep 12, 2020

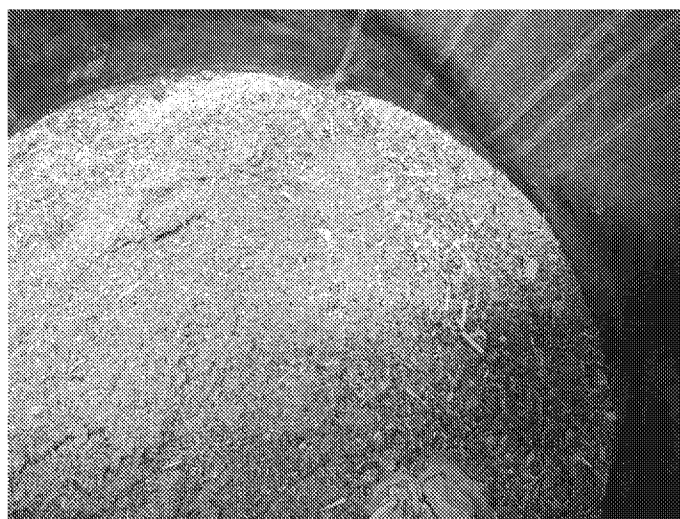
Image 6. Black crumb collected from river. Photo taken Sep 12, 2020

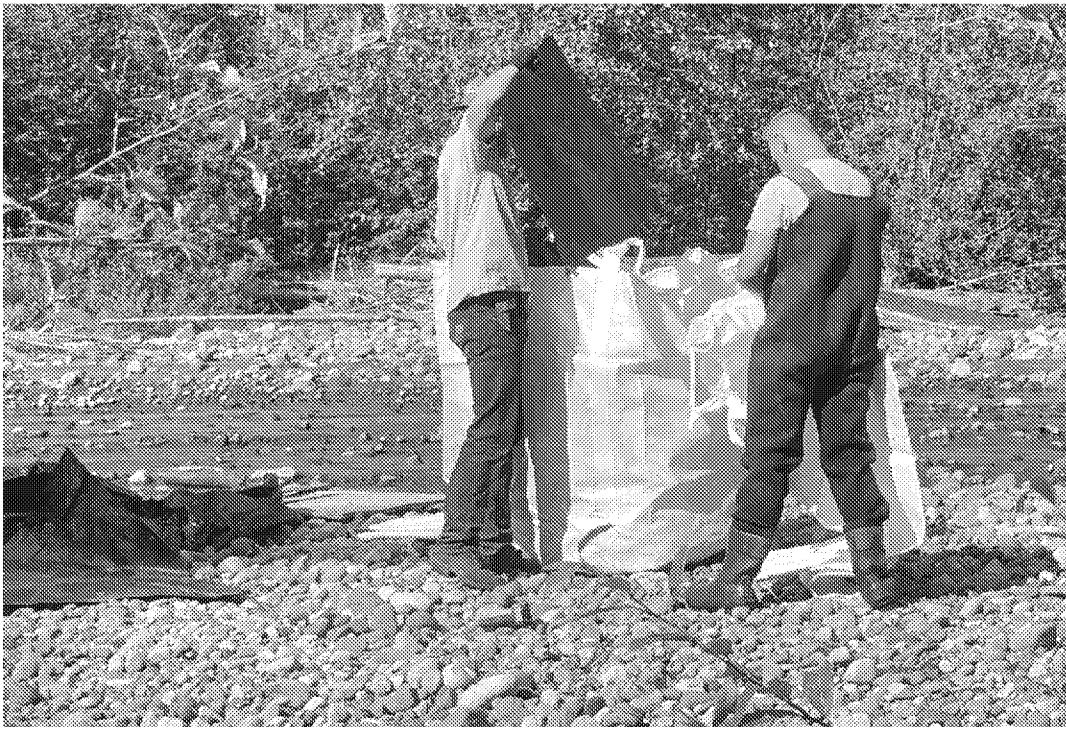
Image 7: Electron crew members packing plastic liner into supersacks for removal. Photo taken Sep 2, 2020

- a. Electron Crew 1 (4 individuals) began survey from Electron Intake and went downstream ~ 2miles in the river noting points from drone survey from the tribe. Found all noted points from tribe (see table 1). Over 90% of the plastic liner and turf was collected and piled up into 4 super sacks worth of debris ~1.75 miles from intake, to be removed safely later. The remaining pieces were verified and found, but water levels were deemed too high to safely remove this day.

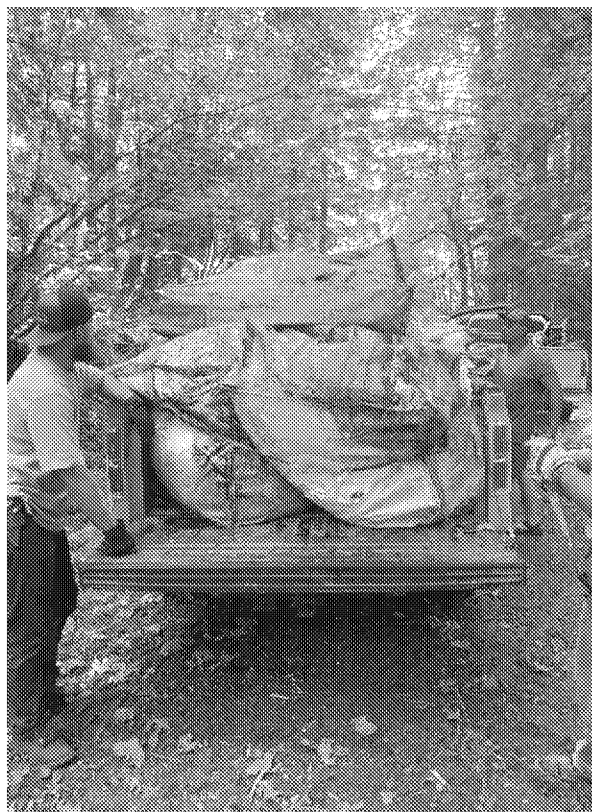
Image 8: Electron crew members packing supersacks of debris to be hauled to company storage container. Photo taken Sep 2, 2020

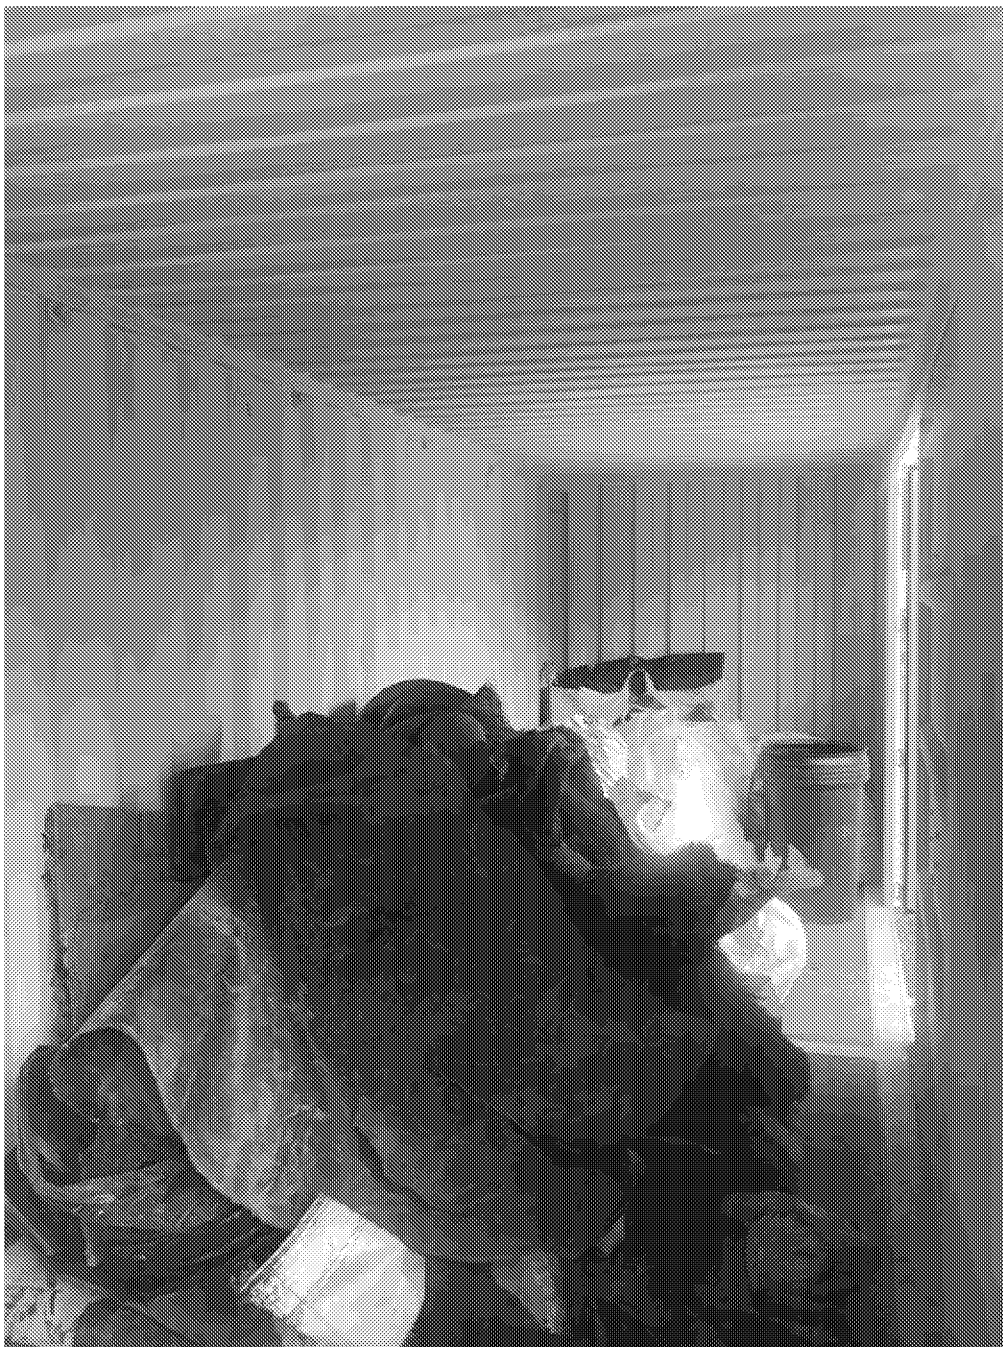
Image 9: All collected Field turf, plastic liner, and black crumb stored in Conex. taken Sep 15, 2020
